# Failure Investigation and Thermo-Mechanical Analysis of Cylinder Liner

Shekhar Shinde, Dr. P. V. Jadhav

Department of mechanical Engineering, Bharati Vidyapeeth Deemed University College of Engineering, Pune, Maharashtra, India

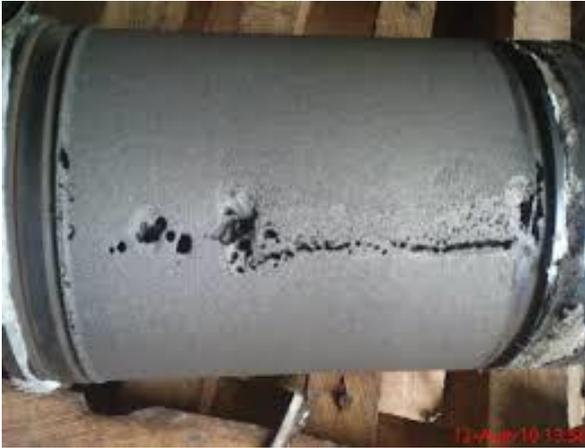
Figure 2(a) : Actual failure component

1. An examination of the internal surface of the cylinder sleeve revealed an elevated number of cavities close to the top centre area, which acted as a stress concentrators reducing the resistance of the component, creating crack nucleation spots.
