# Optimization of Radiation Protection of Patients in Mammography Examinations using compression analysis

## ABSTRACT

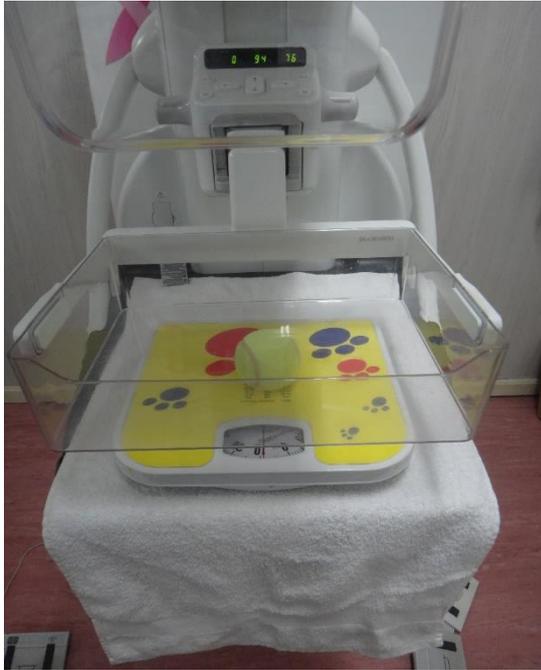
**Figure 1:** Set – up for measuring Compression force in Power and Manual Mode

The bathroom towel was placed on the breast support and the bathroom scale was placed on it centrally directly under the compression paddle. A lawn tennis ball was placed on the scale to protect the compression plate and such that it does not obscure the reading on the scale. The reading on the scale was adjusted to point “Zero”. The compression paddle was activated so that it operated and stopped at the maximum available powered force of 150 N. The compression foot pedal was activated for a second time to secure the compression plate. The deflection on the bathroom scale and the value of the displayed compression force were both recorded in kilogrammes (Kg) and Newton’s (N) respectively. The compression plate was released. Displayed value accuracy should be within  $\pm 20$  N. Results are presented in Table 1.

Using the same set-up as the powered compression mode, the compression plate was moved downwards manually until it stopped. The deflection on bathroom scale and the value of the compression force were both recorded on the data collection sheet in Kilogrammes (Kg) and Newton’s (N) respectively. The compression plate was released. Displayed maximum manual compression force should be less than 300 N. Displayed value accuracy should be  $\pm 20$  N. Results are presented in Table 1. Set – up for measuring compression force in Power mode and Manual mode is presented in figure 1.

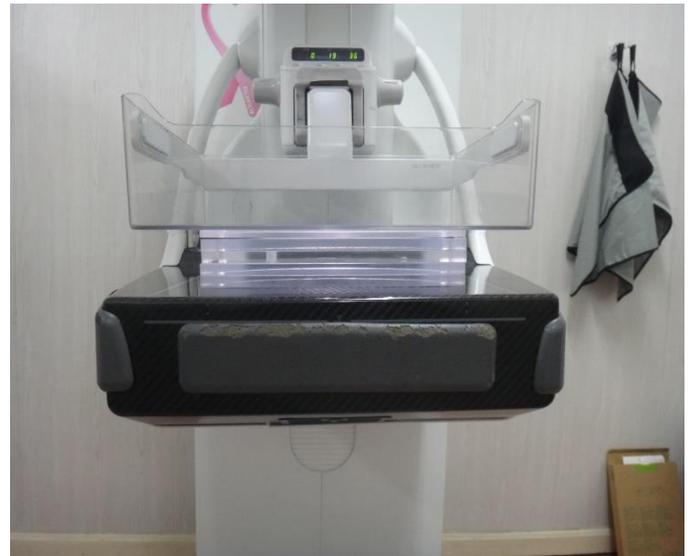
**Figure 2:** Set –up for measuring compression thickness

The PMMA slabs (20 mm, 45 mm and 70 mm) was aligned with the chest wall edge of the breast support platform. The compression paddle was activated so that it operated and stopped at the maximum available powered force. The measurement of the thickness of the slabs was taken centrally. The measured thickness and the displayed thickness were all recorded and inputted into the data sheet. Tolerance limit is for the displayed thickness to be within  $\pm 5$  mm of phantom thickness. Results are presented in Table 2. Set – up for measuring compression thickness is presented in figure 2.

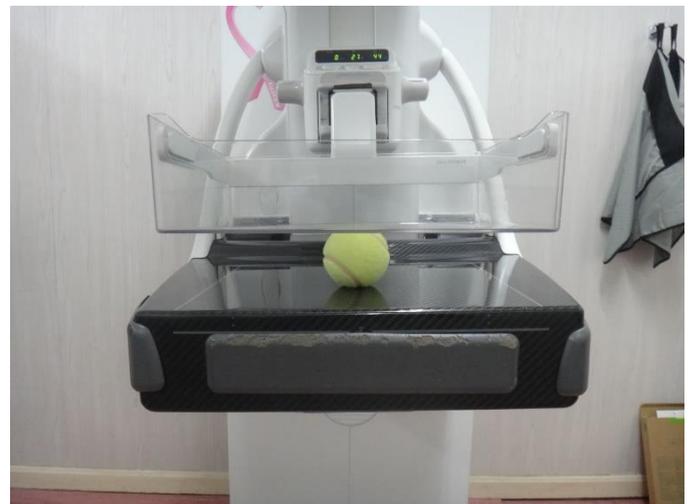
**Figure 3:** Set –up for measuring compression alignment

The alignment of the compression device at maximum force was visualized and measured when the lawn tennis ball was compressed. The distance between breast support surface and compression

device on each corner was measured. The compression device was released. Minimal misalignment of the compression plate is allowed, the difference between the measured distances at the left and the right side of the compression paddle should be  $\leq 5$  mm for symmetrical load. Results are presented in Table 3. Set – up for measuring compression alignment is presented in figure 3.
