CFRP Application in Retrofitting of Masonry Wall

ABSTRACT

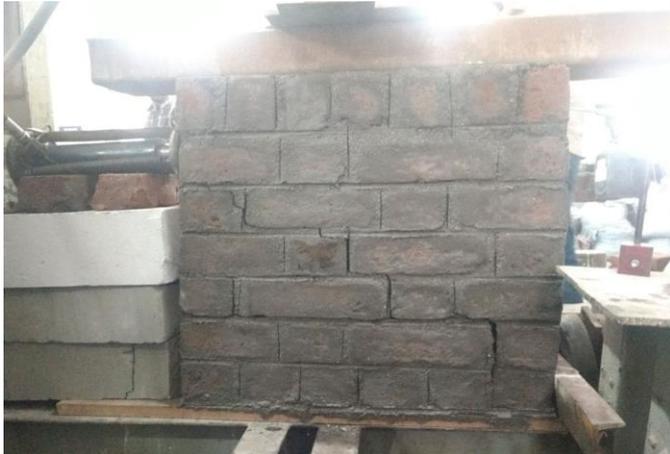
Diagonal shear crack appeared from top left corner to the bottom right corner.

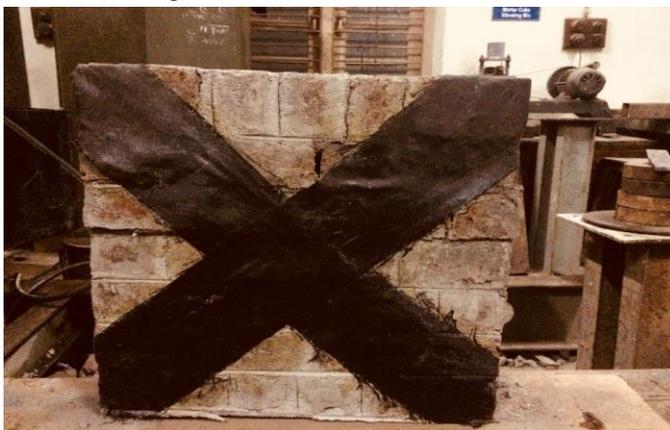
Due to wrapping the failure pattern changed from diagonal shear crack to sliding failure.
