# Methodology of Life Estimation of Bagasse Carrier Chain

B. D. Gaikwad<sup>1</sup>, A. B. Chounde<sup>2</sup>

<sup>\*1</sup>Department of Mechanical Engineering, SVERI'S College of Engineering, Gopalpur - Pandharpur, Maharashtra, India

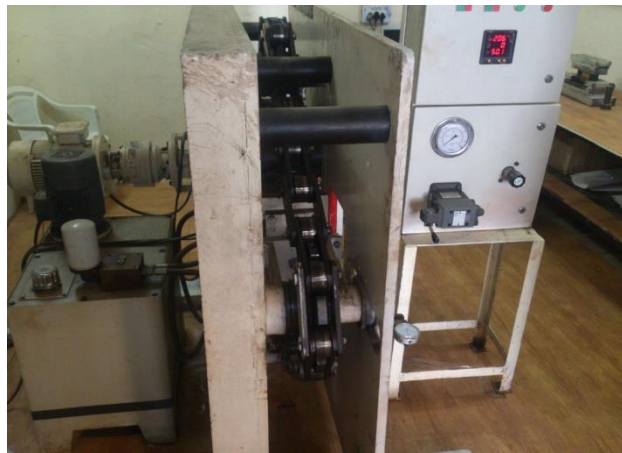
**Figure1:Experimental set up to find elongation of chain on preloading and length measuring machine**

As per the figure 1 driving shaft connected to electric motor. One it keyed sprocket having rotational movement driven shaft also having keyed sprocket. But it has two movement one is rotational second one is transverse. In between two shaft two idler to adjust slackness or conveyor. The transvers movement of driven shaft is done by hydraulic power pack unit and its movement is measure by calibrated dial gauge. Following graph is developed

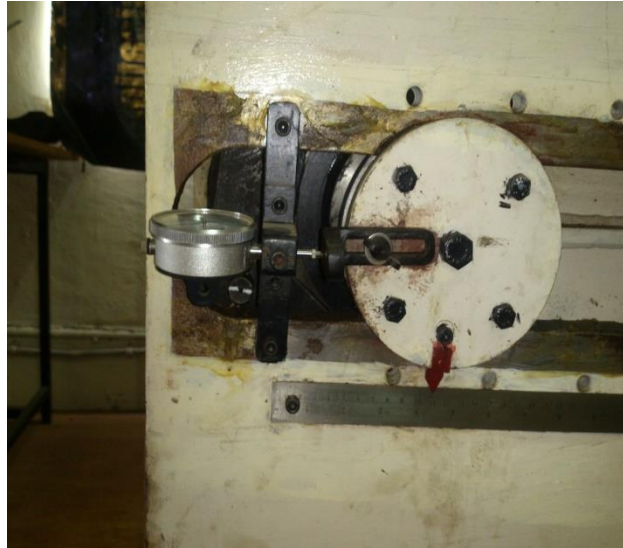
Figure2:Dial gauge location for measuring elongation of chain
