Assessment of Erosion Control Measures A Case Study of Birnin Kebbi, Nigeria

ABSTRACT

The research was carried out to assess the erosion control measures in Birnin Kebbi. The Research was conducted in an area affected by flow of water causing erosion leading to gully type. Widths of the eroded area were used as basis for observation for the research. The depth of the eroded area varies considerably from upstream to downstream. Downstream is shallow which is due to deposit of materials while upstream is as deep as 2m or more in some areas. Gabion, dyke and five (5) species of grasses that include Bahama Grass *Cynodon dactylon*, Sicklepod *Cassia obtusifolia*, *Leptadenia specie Leptadenia lancifolia*, Castor plant *Ricinus communis* and lovegrass *Eragrostis tremula* were used as erosion control measures for the research. The control measures were assessed for three consecutive years from 2013 to 2016 and the results of the research shows an average width increment of 1.08m for dyke and 0.92m for gabion while the area treated with vegetation has width increment of 0.62m and 0.55m for grass combination of three and five respectively. The result shows that area treated with grasses

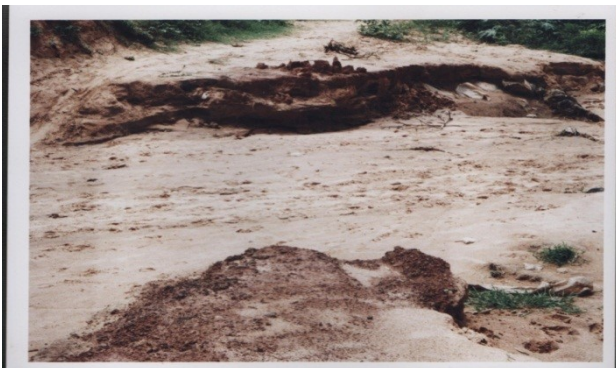
Plate 6. A Eroded Width in The Research Area of Section A

water was divided into A, B, C, D, and E, sections towards the end part of channel at downstream where it is expected that the velocity of flow is maximum. Section A, used as control was left untreated naturally as it is while a dyke was constructed at section B. Gabion was used at section C as means of control and section D is the area where combination of five types of grasses that include Bahama Grass *Cynodon dactylon*, Sicklepod *Cassia obtusifolia*, Leptadenia specie *Leptadenia lancifolia*, Castor plant *Ricinus communis* and lovegrass *Eragrostis tremula* were used as control measures. Section E was treated with three different species of grasses that include Sicklepod *Cassia obtusifolia*, Castor plant *Ricinus communis* and lovegrass *Eragrostis tremula*.

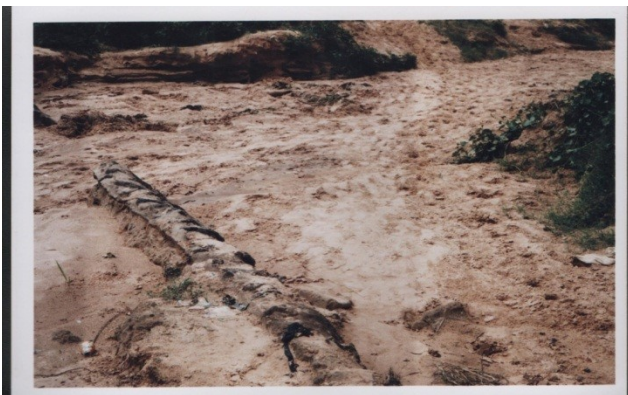
Plate 7. Area where Dyke was Used

The Results obtained in the research shows that area treated with Dyke has an average width increment of 1.08m while the area where gabion was used show an average width increment of 0.92m and the area treated with vegetation has less width increment of 0.55m and 0.62m for combinations of 5 and 3 different grasses respectively over the period of the study. The result of the research indicated that vegetation is more effective measure of erosion control as it has less width increment for two combinations compare with other measures adopted for the control. The result of the study also shows that gabion is more effective erosion measure than dyke as it has a less width increment when compare to dyke for the period of study.

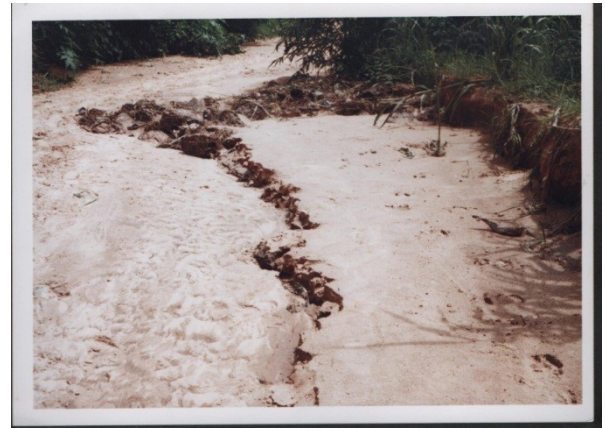
Plate 8. Area where Gabion was used

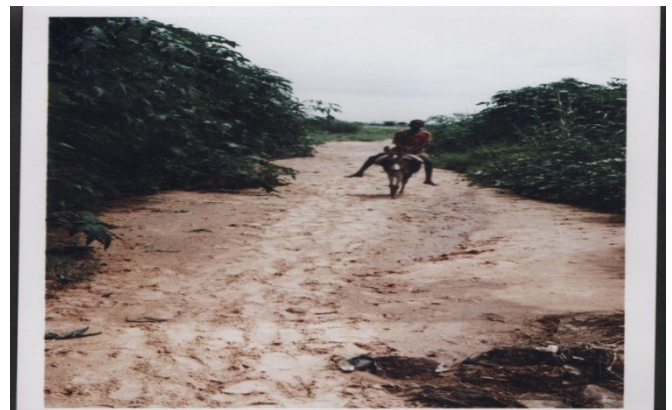
Plate 9. Use of Combination of Five Grasses

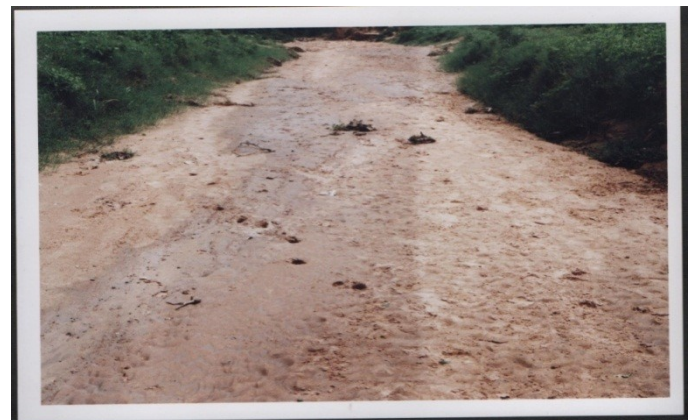
Plate 10. Use of Combination of Three Grasses

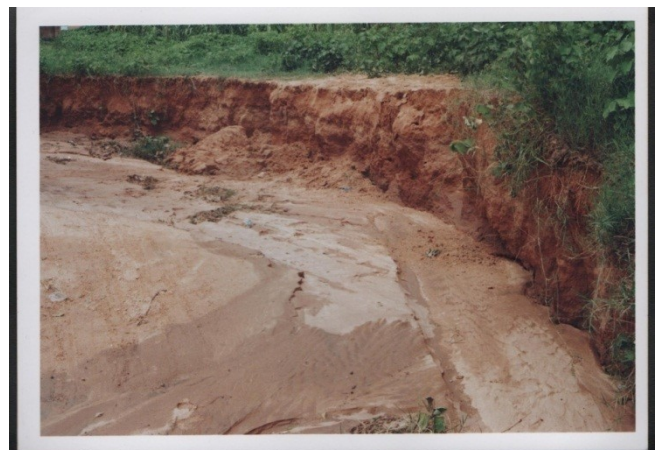
Plate 11. Upstream Area Developed Gully Erosion
