Structural Audit of 40 year old Silo

The crucial objective of present work is to adopt Structural Auditing of 40 years old silo which is situated at Somnath (Gujrat) with Schmidt's Hammer Test, Ultrasonic Pulse Velocity Test, Cover Meter Test, Half-cell test, pH test including Visual Inspection And Assessing the stability and safety of the structure to withstand for its remaining life by Diagnosis and root cause of the problems with remedial measures.

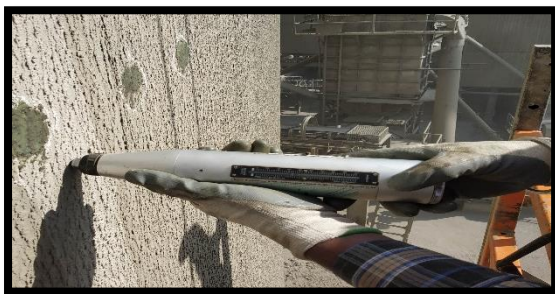
Fig 1. Rebound Hammer

2. Rebound Hammer Test the tactic is predicated on the principle that the rebound of an elastic mass depends on the surface hardness averse which mass strikes. When the plunger of rebound hammer is pressed on the surface of the concrete, the spring controlled the mass of rebounds, Hence the extent of such rebound depends on the surface hardness of concrete. Rebound are related with the compressive strength of the concrete. The rebound number and index are read from graph provided on rebound hammer along a graduated scale. For finding the measurement, the hammer should be place at right angles to the concrete surface. The test are calculated horizontally on vertical surfaces

and vertically upwards or downwards on horizontal surfaces.

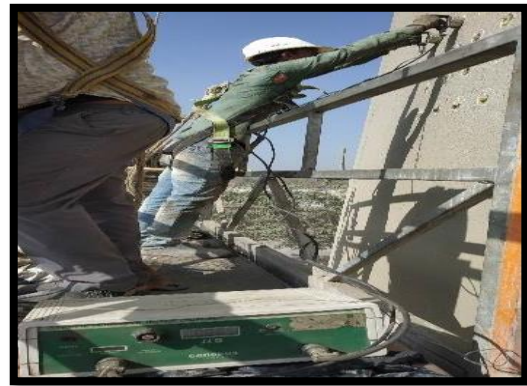
Fig 2. U.P.V Test

3. Ultrasonic Pulse Velocity Test A throb of longitudinal vibrations is produced by an electro-acoustical transducer, which is held in touch with one surface of the concrete under test. When the throb generated is transmitted into the concrete from the transducer employing a liquid coupling material like grease or cellulose paste, it undergoes multiple reflections at the boundaries of the varied material phases within the concrete, a push system of stress waves develops, which include both longitudinal and shear waves, and propagates through the concrete. The primary waves to achieve the receiving transducer are the longitudinal waves, which are converted into an electrical signal by a second transducer. Electronic timing circuits enable the transit time T of the pulse to be measured and the pulse velocity is determined by path length by transit Time. Pulse

Velocity in concrete will be represented in Km/sec or M/s. The instrument indicates the time taken for the earliest a part of the heart beat to succeed in the receiving transducer measured from the time it leaves from an appropriate point on the surface of the material.

The instrument indicates the time taken for the earliest a part of the heart beat to succeed in the receiving transducer measured from the time it leaves from an appropriate point on the surface of the material.

The path length and transit time are measured to determine the pulse velocity. The velocity of longitudinal pulse in elastic solids. It are often shown that the speed V of pulse of longitudinal ultrasonic vibration traveling in an elastic solid is given by:

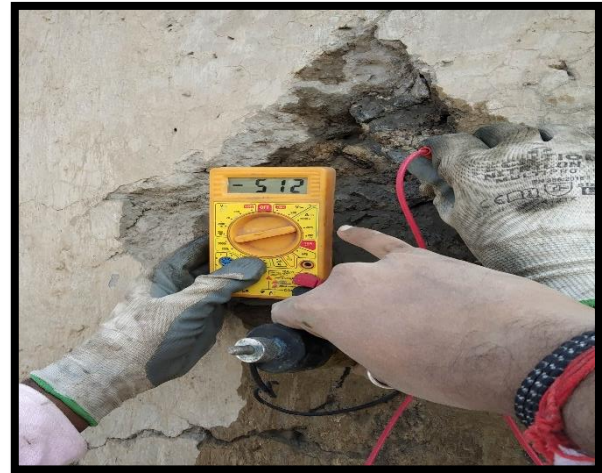
Fig No.-3.Half cell test

4. Half Cell Test- The half-cell potential method measurements normally involves measuring the potential of an embedded reinforcing bar relative to a reference half-cell placed on the concrete surface. The half-cell is typically a copper/copper sulphate or silver/silver chloride cell but other combinations are used. The concrete functions as an electrolyte and therefore the risk of corrosion of the reinforcement within the immediate region of the test location could also be related empirically to the measured electric potential difference. In some circumstances, useful measurements are often obtained between two half-cells on the concrete surface. ASTM C876 - 91 gives a typical Test Method for Half-Cell Potentials of Uncoated Reinforcing Steel in Concrete. Risk of Corrosion Against Potential

Difference Reading. This technique is presumably to be used for assessment of the sturdiness of reinforced concrete members where reinforcement corrosion is suspected.

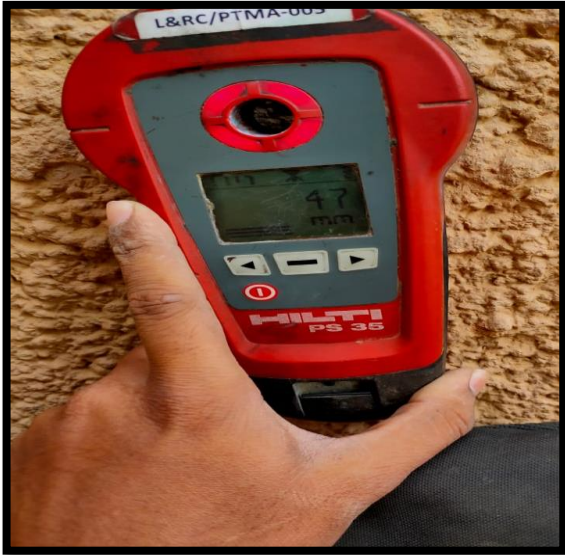
Fig No.4-Cover merer

5. Cover Meter Test a cover meter is a device designed specifically for determining the "cover" to reinforcement bars in concrete. Location of embedded rebar's & estimation of size of embedded rebar's. Cover is defined as being the distance from a given surface of a concrete element to the nearest part of a reinforcement bar or other embedded item. Knowing the diameter of the bar and their location is essential to understand the bar spacing and their placement, in existing structures where there are not any structural drawings available. The cover thickness is significant from the aim of view of estimation of initiation of corrosion. Cover meter is significant to form sure longer life for the structure.

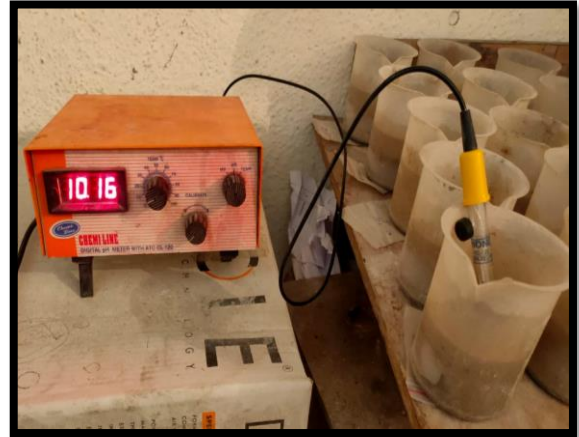
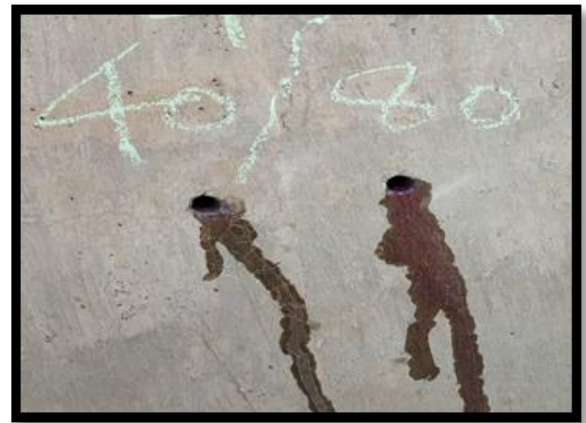
Fig No.-5.PH TEST

6. pH Test when the CO₂ in atmosphere within the presence of moisture reacts with hydrated cement, Carbonation of concrete occurs. Carbonation process is additionally called as depassivation. Carbonation of concrete is related to the corrosion of steel reinforcement and with shrinkage. The method to establish the extent of carbonation in concrete by applying a solution of 15mg Phenolphthalein & 10ml Ethanol diluted in 50ml of distilled water to a fresh fracture surface of concrete. The change of Pink color of concrete indicate carbonation free concrete while the uncolored indicated carbonation. The pH of concrete lowers when the carbon dioxide in the air

comes in contact with concrete, the process is called carbonation. A standard pH meter is used to measure the pH of concrete. If pH value between 7 to 9 Concrete starts to break down and pH of the concrete below 8.6, suggesting carbonation.

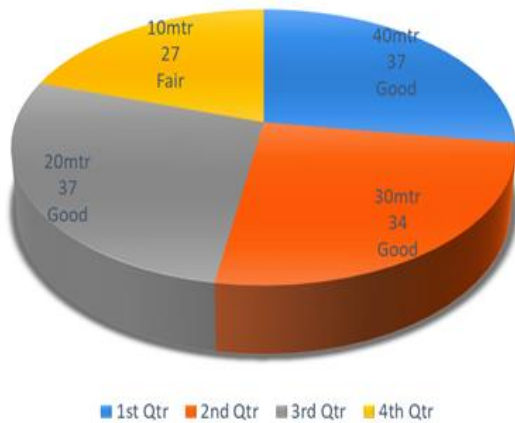
1. Rebound Hammer Test Results

>40-very good, 30-40-Good, 20-30-Fair, <20-Poor Concrete

Based on all Nondestructive test results R.C.C silo needs structural strengthening and repairing work with help of injection grouting and polymer concreting work and rebarring whenever need and some places need micro concreting and Anodic protection for steel corrosion and for paint anti corrosive paint which side reinforcement exposed two coat of anticorrosive paint and polymer concreting is required.

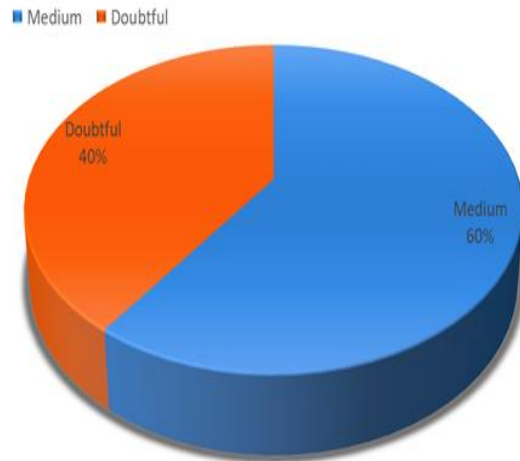
2. U.P.V Test Results

>4.5-Excellent, 3.5-4.5-Good, 3.0-3.5-Medium, <3.0-Doubtful

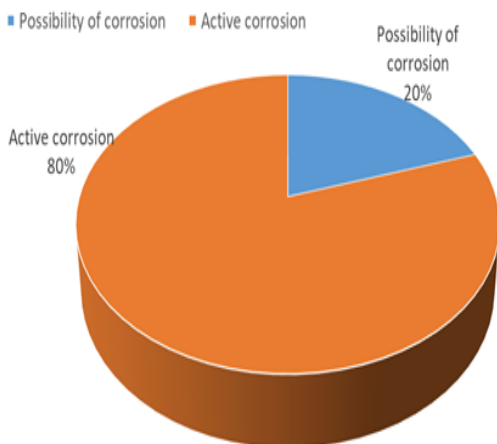
3. Half Cell Test Result

Below -250 NO Corrosion, -250mv to -350mv Possibility of Corrosion, Above -350 mv Active corrosion

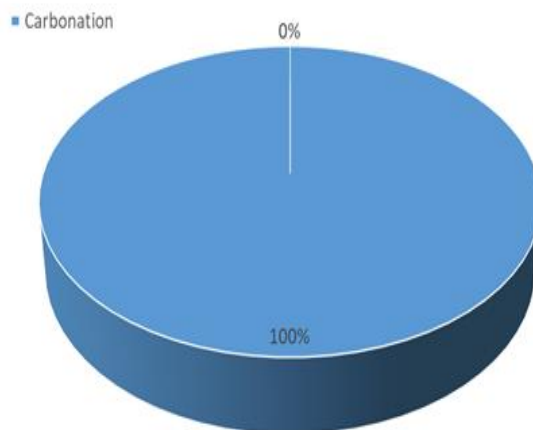
4. PH Test Result

PH Above 8.6 Suggesting Carbonation
