# Response of Hydro-Meteorological Hazards to Environmental Degradation in Kohima District of Nagaland, North East India

## ABSTRACT

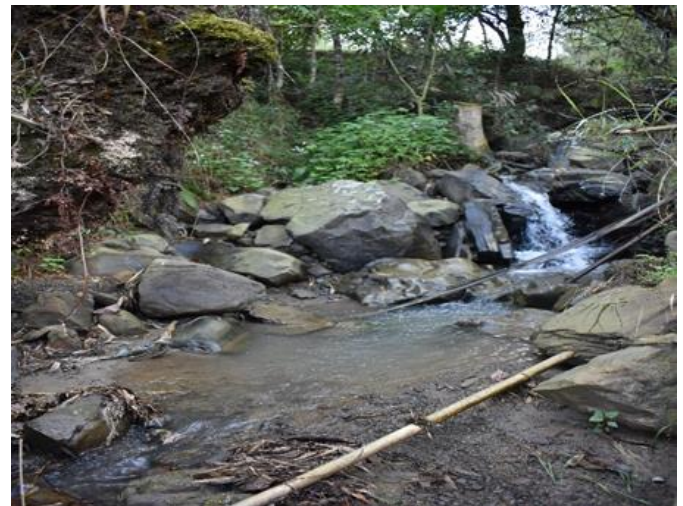
**Plate 1:** Stream flow of the Mezi ru micro catchment during the pre-monsoon month of May 2019.

Heavy monsoon rainfall highly impacts the river, causing heavy overland flow and land degradation. Huge and rounded boulders downstream indicate the impact of heavy floods during monsoon season. Also, with the seasonal agricultural practices of paddy cultivation, there is an indication of human interference in stream flow due to water diversion for irrigation purposes. Though the watershed is dominated by dense forest cover, the environment around the terrace fields has a feeble forest cover with more rocks than soil which add to the cause of landslides, debris flow and rockfall.

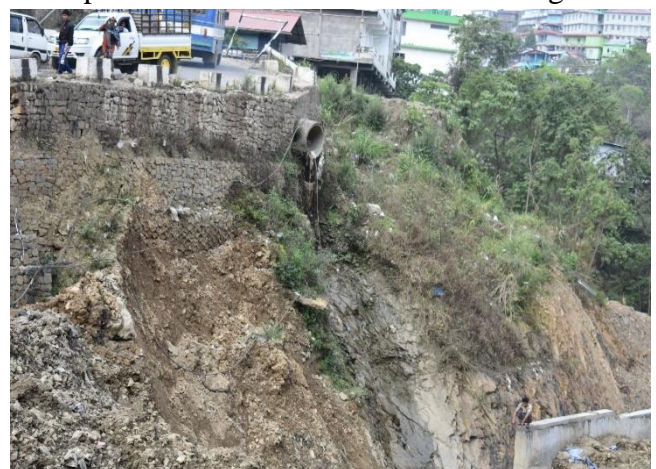
**Plate 3:** Landsliding along the bank of the river Sano ru.

Sano ru is geologically a disturbed landscape because of the presence of a major fault along the river which contributes to multiple landslides in the catchments almost every annual monsoon season. It is located between 94°03' - 94°21'E longitude and 25°67' - 25°79' N latitude at an elevation ranging between 909 m-1520 m covering an area of 23.42 sq. km. The catchment has a sinking nature due to the major fault in the area. Also, the prevalent heavy rainfall experienced in the study area causes the catchment to experience massive landslides almost yearly. The road along the river,

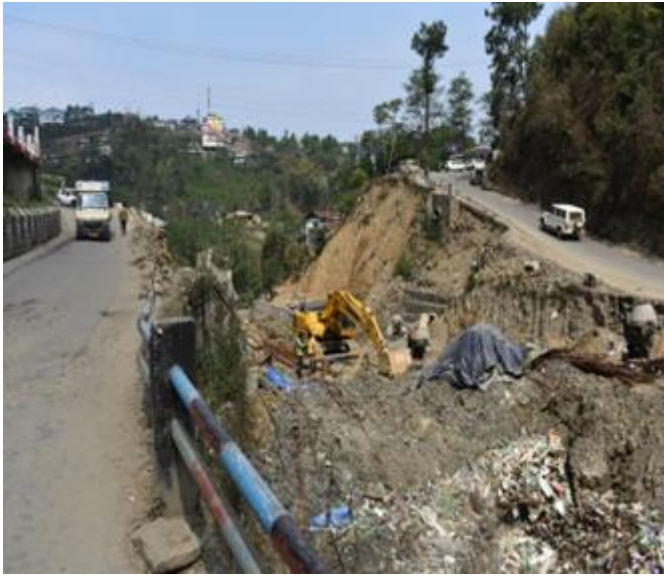
**Plate 4:** Landslide and subsidence along Sano ru, where a road connects the Secretariate with the rest of the district

which connects the rest of the district to the civil secretariat, is always under heavy modifications by building huge barriers along the river to control excessive flash floods, which causes great inconvenience to the settlements in and around. The catchment upstream is densely forested. However, it becomes densely populated with built-ups and settlements downstream. The catchment though naturally and geologically disturbed, has become an urban disturbed landscape and landform because of immense additional disturbance by road constructions, settlements and huge disposal of waste in the river itself, all of which collectively intensify the effect of hydro-meteorological hazard, particularly landslide and flash flood in the area.

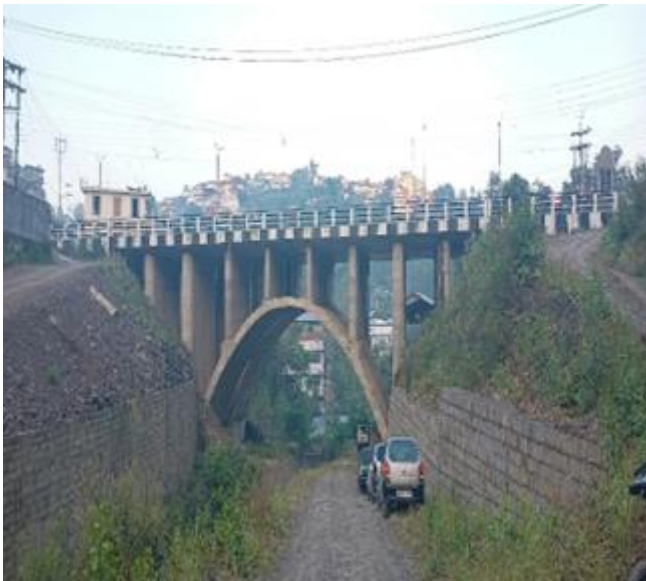
**Plate 5:** The newly constructed bridge along the river where the old road has been abandoned

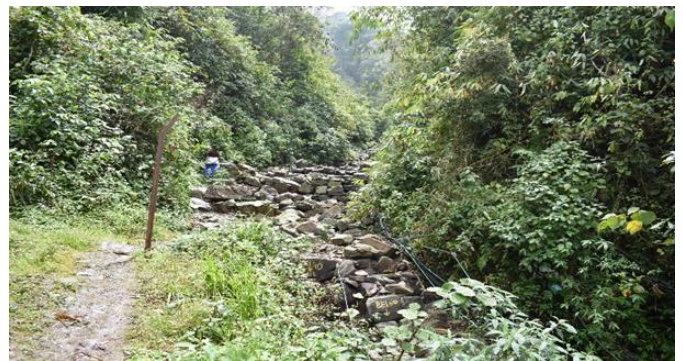
**Plate 6:** Upstream of Dzuna ru

The forest vegetation upstream accounts for 70-80%. However, due to increasing water pipelines upstream and low rainfall during the winter and pre-monsoon months, stream flow has reduced a great deal experiencing drought-like situations except during the

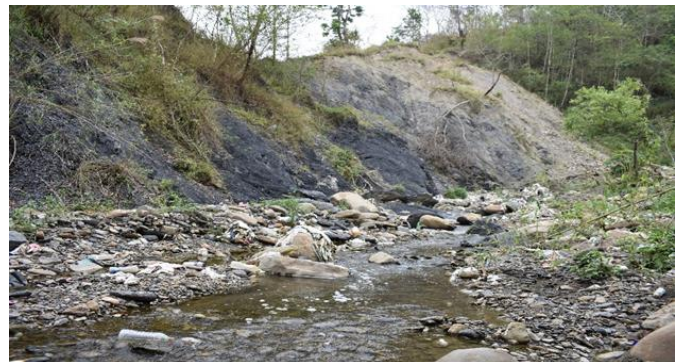
**Plate 7:** Downstream of Dzuna ru.

The Dzuna ru catchment downstream is a different scenario owing to the construction of the KMC waste disposal site. The water downstream is exceptionally polluted due to improper practices of waste disposal by the municipal. The surrounding area of the watershed is bounded by road cutting and construction connecting the North to the southern part of the Angami region, Kohima. This has led to massive deforestation with only a little vegetative cover, and the rocks found downstream are seen to be changing in formation because of the highly polluted water. Also, during the monsoon season, due to the clogging of the river by waste materials, the river becomes flooded and stagnant with contaminated water, causing land degradation and vegetation along the stream. Heavy road construction around the catchment has also resulted in deforestation leading to landslides. This watershed's landuse system can be considered an urbanised landuse system with massive disturbance on the river's natural ecosystem, leading to decreasing water flow, flash floods, decreased forest cover, landslides and contaminated water. The catchment located at the heart of Kohima town becomes comparatively exposed to human-induced threats. Despite its very high potential of serving as a source of providing drinking water to the people, proper monitoring is necessary for the catchment to suffer more threats than the valuable service it can provide.

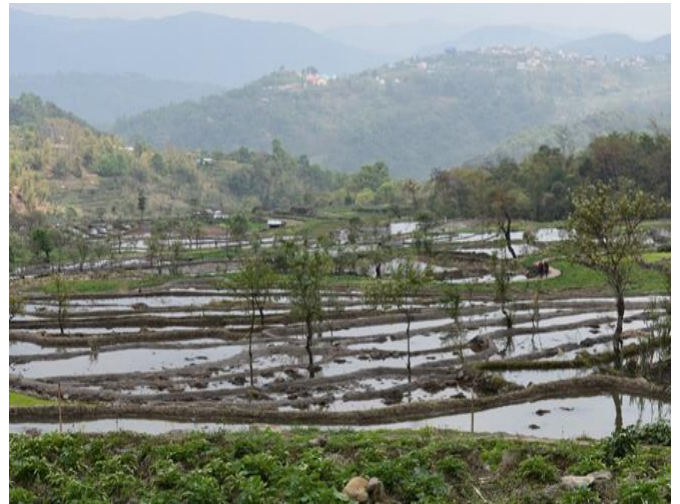
**Plate 8 :** Terrace cultivation is done in the watershed area
