# Design and Development of Corrosion Resistance Coating for Pipes in Fire Protection Sprinkler Systems : A Review

Jitendra Jangid,

Manipal University of Higher Education, Dubai

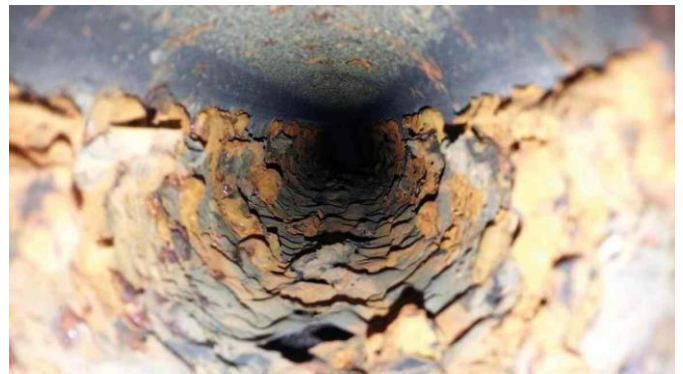
**Figure 1: Severe corrosion inside steel pipe of a wet type fire sprinkler system (image by IFP: The problem of corrosion in metal fire sprinkler system 2017**

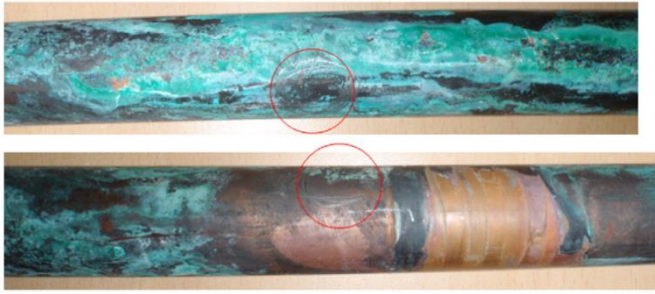
**Figure 2: Corrosion failure copper tubes, red circles display water leakage locations [44]**

According to the experiment carried out by Sang Hee Suh and team, "There is a significant amount of pressurized air over the water in the copper tube and all the corrosion pits observed in this study were located near the water/air-line mean that the pitting corrosion was caused by the waterline corrosion"[44]. The pressure air pocket in the copper conduit over water induces pitting corrosion in it [44]. The copper pipes used in this study for the sprinkler systems consist of phosphorus de-oxidized copper with an interior diameter of 25 mm and a thickness of 0.89 mm [44]. When unloading the gas in the tube alone through the control valve or other buttons, it becomes nearly difficult to get rid of fuel. This is because there is no other choice than to stay in the tube and absorb the air immediately associated with the sprinkler mouth [44]. It has been suggested that the future material of tube applications for fire-
